Clintwood Elementary School Facilities Condition Assessment Report

Dickenson County Public Schools

**Prepared by OWPR, Architects and Engineers
200 Country Club Drive
Blacksburg, Virginia**

Field investigation was performed on February 7, 2018

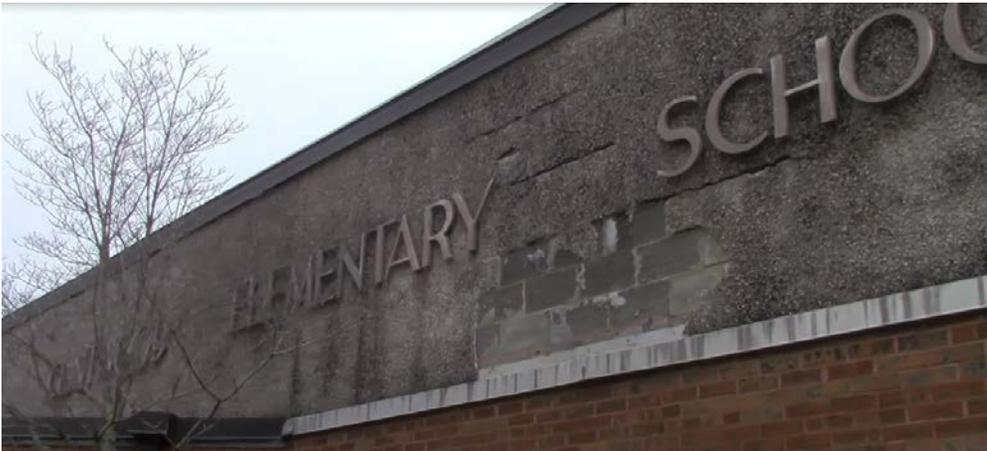
Exterior: The exterior wall material is predominantly brick. Brick was observed to be in good condition. At the top of the exterior walls, a pebble aggregate faced panel transitions the brick to the roof edge. These panels are in poor condition and are delaminating.

Damaged façade panels at front of school

- Recommendation (5 Year): Replace pebble aggregate faced panels with new pre-finished aluminum panels on furring channels.
- Recommendation (10 year): No action

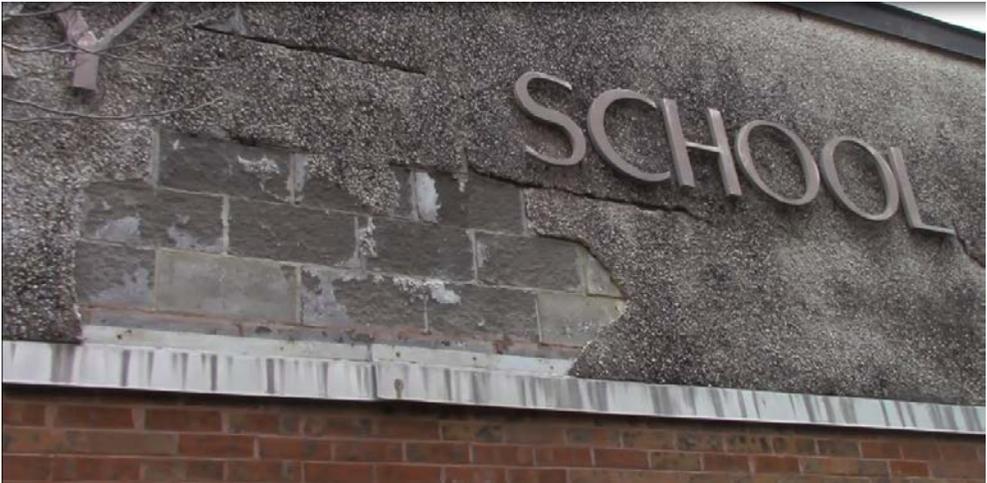
Exposed cmu at damaged façade panels

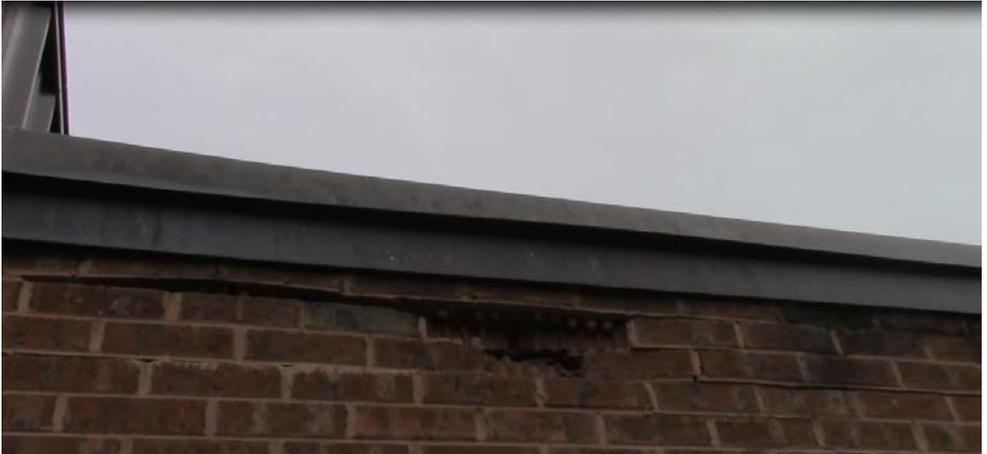
There are some structural issues in the building. On the exterior of the building, there are several areas where the brick façade has cracked, and the brick have moved out of alignment. This is likely a combined result of no control joints in the brick and a possible roof/parapet leak that has allowed water to get behind the brick and freeze. There are also some cmu cracks within the building. The floor settlement adjacent to the Kitchen was discussed earlier in the report, along with a recommendation.

Damaged brick at roof

- Recommendation (5 year): Repair the brick on the façade and add a control joint in this general location. The roof replacement should address any water getting behind the brick. Monitor the cmu cracks on the inside of the building and if they appear to get larger, a structural engineer should further investigate.
- Recommendation (10 year): Monitor building façade and interior cmu for further cracks.

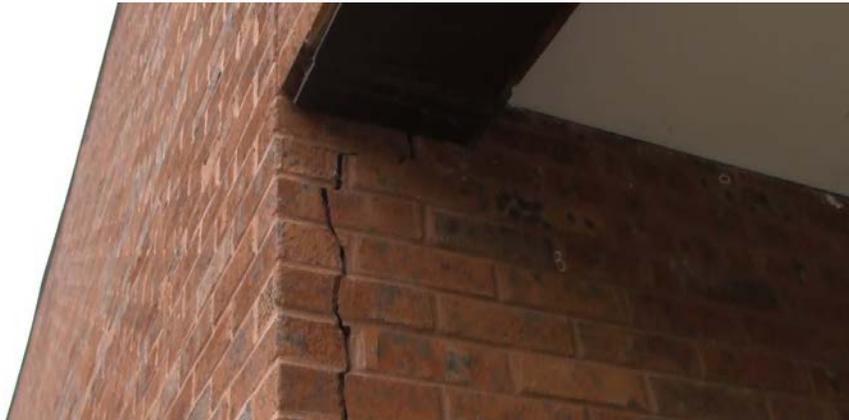
Crack in brick at lintel

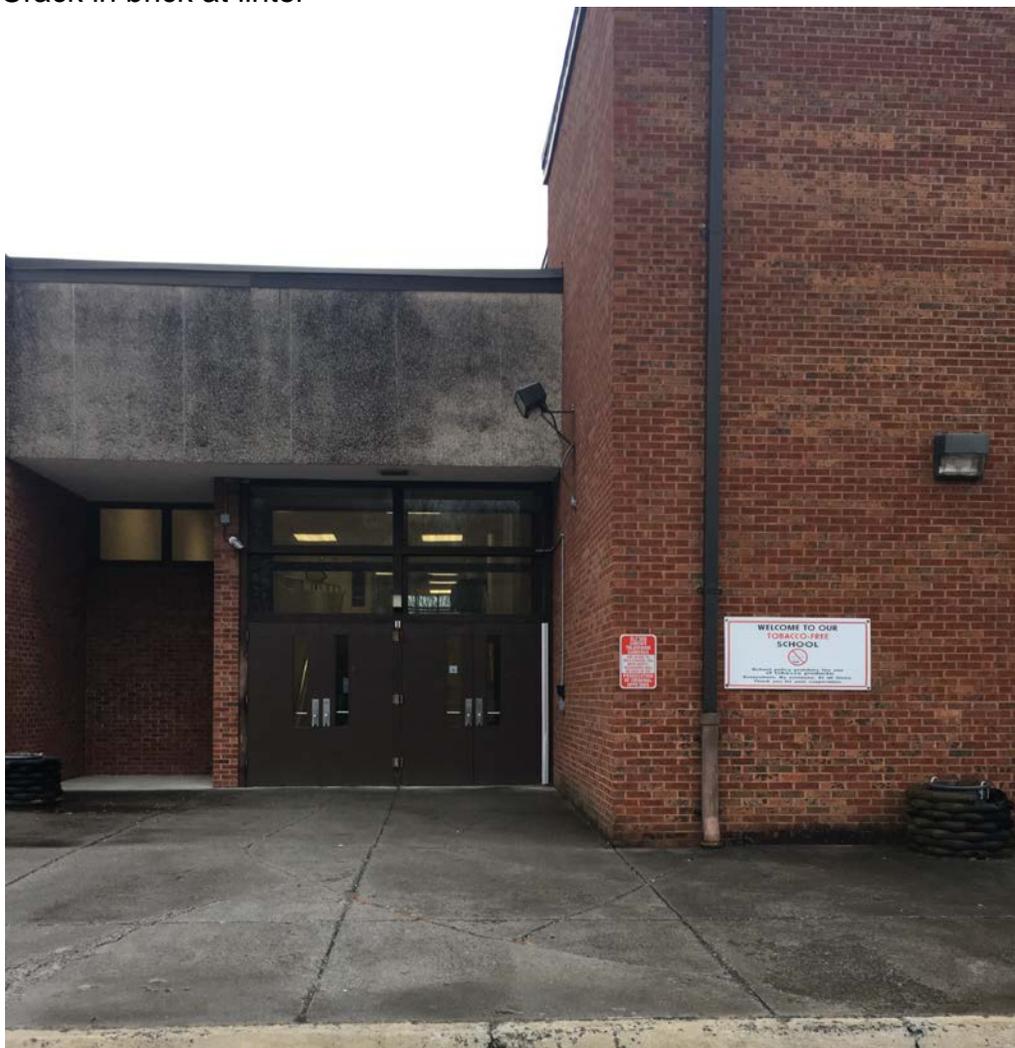
Worn façade panels at entrance

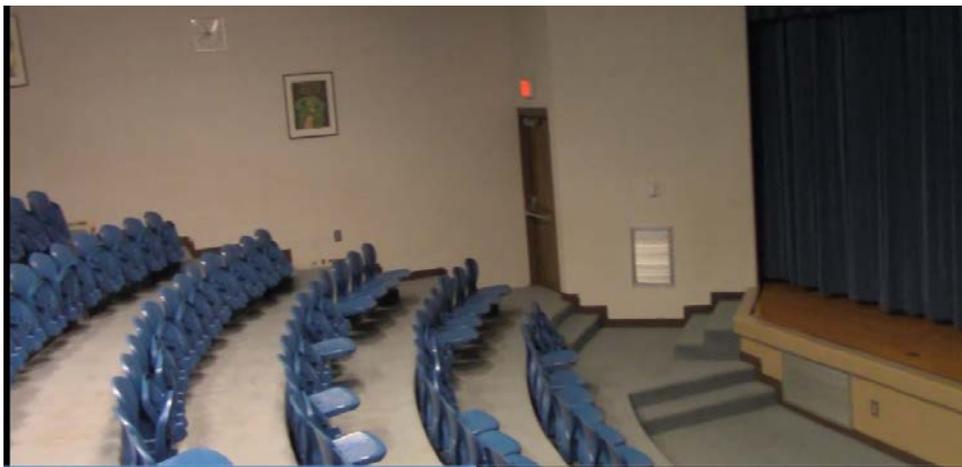
Multi-tiered auditorium not ADA accessible at stage

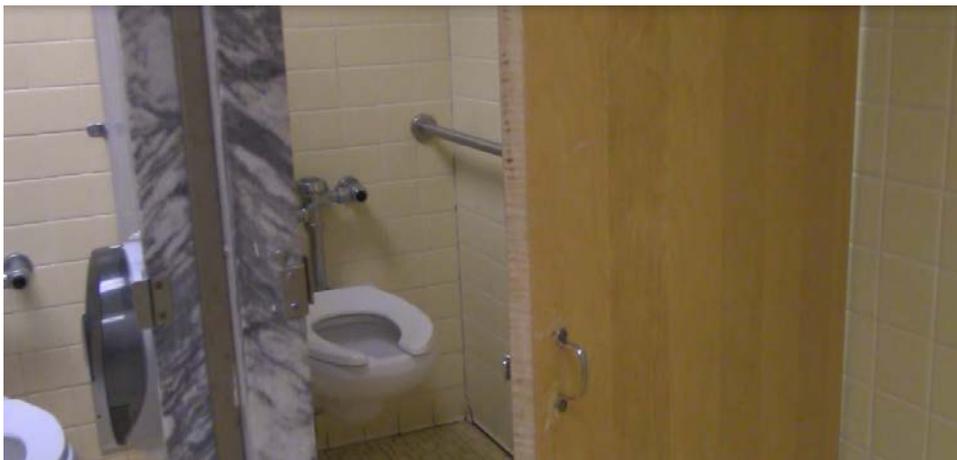
Floors (Restrooms): The boy's and girl's restroom floors are mosaic ceramic tile and are in good condition, however, these areas will likely require significant renovation to make them handicap accessible.

Restroom adapted for handicap use does not meet current standards

- Recommendation (5 year): Maintenance
- Recommendation (10 year): Replace all ceramic tile in restrooms as part of a restroom renovation.
